The stronger the better is not necessarily the case for fasteners

By Bill Eccles, Bolt Science

Originally published in Fastener + Fixing Technology Issue 11, October - December 2013.

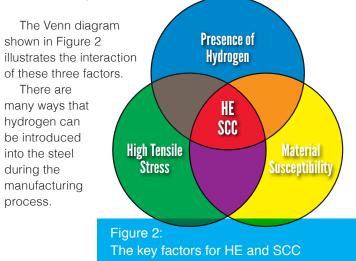
Figure 1: M10 electroplated 12.9 screw cracked under the head the hydrogen enters the steel. Once atomic hydrogen is introduced at the surface of the part, there is a migration of the hydrogen over time to the grain boundaries, flaws and inclusions in the material. The effect of the hydrogen is to cause a reduction in the defect formation energy and a decrease in the inter-atomic bonding energy. Atomic hydrogen can also bind together to form hydrogen gas (H2) whose pressure build-up at a crack tip can also have a deleterious effect. By these mechanisms a normally ductile material can behave in a brittle manner. With the fastener under stress (which usually means once it is tightened), cracks are initiated once the local concentration of hydrogen, at a particular defect, exceeds some critical value.

> 1 shows a M10 electroplated 12.9 socket head cap screw cracked under the head due to embrittlement. One of the characteristics of hydrogen embrittlement is that it may only affect a small proportion of a batch of fasteners.

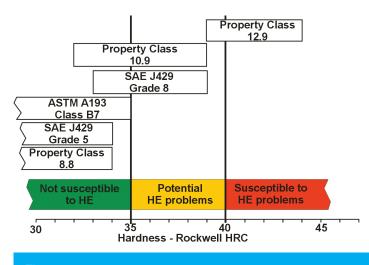
Figure 3: Common bolting materials and their susceptibility to hydrogen embrittlement

Although the alloy content and microstructure has some effect on the susceptibility of steel to hydrogen embrittlement, it has been found that the strength level (hardness) is the key factor. In general, the higher the strength of the steel, the greater is the susceptibility to hydrogen embrittlement. The chart shown in Figure 3 summarises the experience of the susceptibility of common fastener strength grades to HE. As a footnote, in some special circumstances (for example in subsea applications in which cathodic protection is used) fasteners of hardness greater than 34 HRC are susceptible to hydrogen induced brittle fracture.
